Limited Visual Dam Safety Inspections

Helemano 6 Reservoir

Oahu, Hawaii

Limited Visual Dam Safety Inspection Conducted on: 3 April 2006

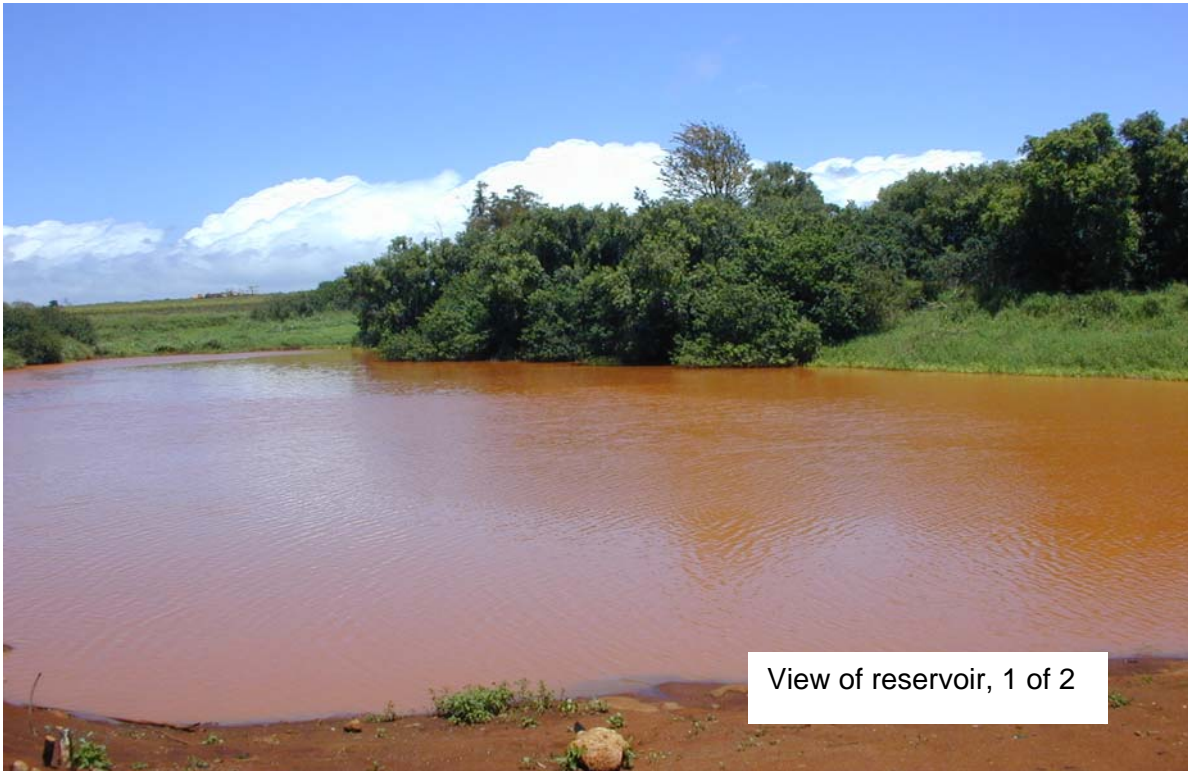
- a. The reservoir was not fully inspected due to obstruction by heavy vegetation and major portions of the reservoir covered by water.
- b. The reservoir appeared to be in satisfactory condition, no corrective actions are required at this time.
- c. A staff gage was not observed at the reservoir. Provide some method of quantifying the water level within the reservoir.

View of reservoir, 1 of 2

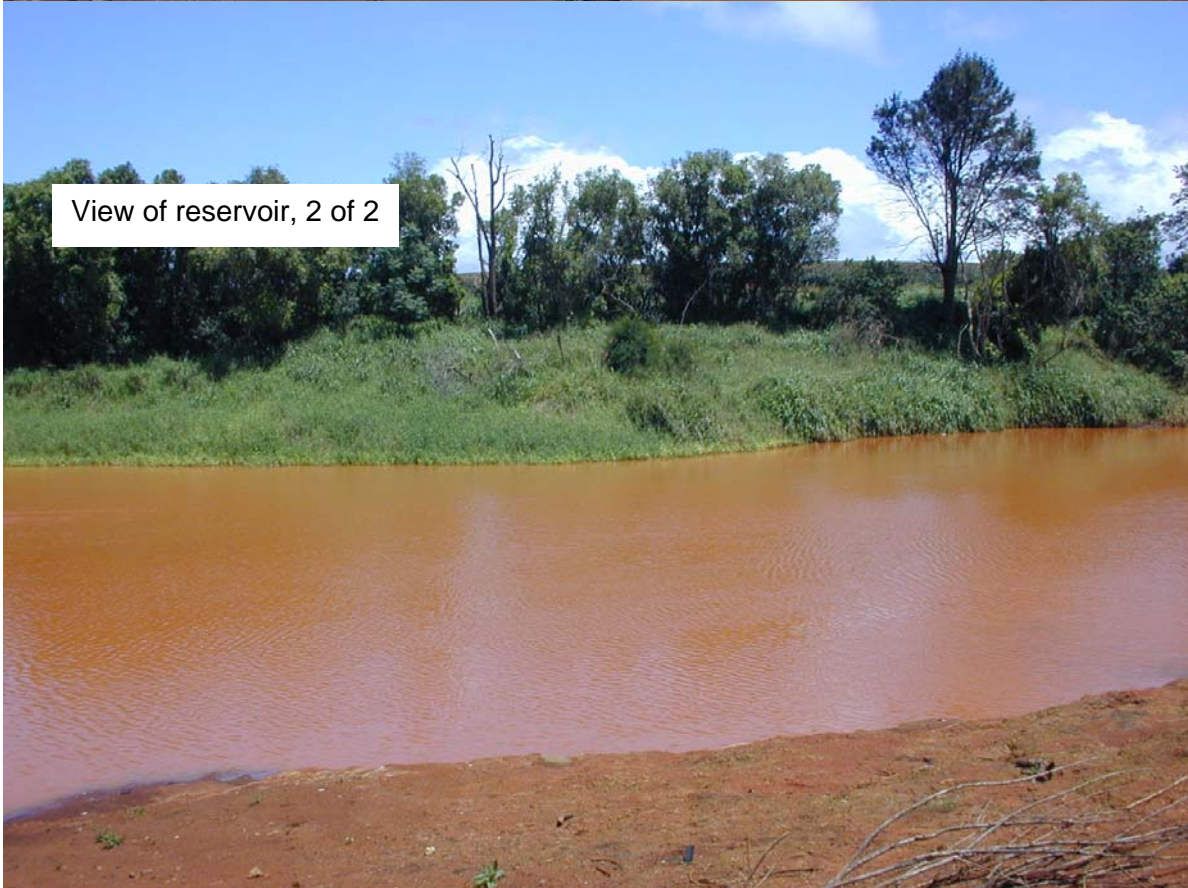
View of reservoir, 2 of 2

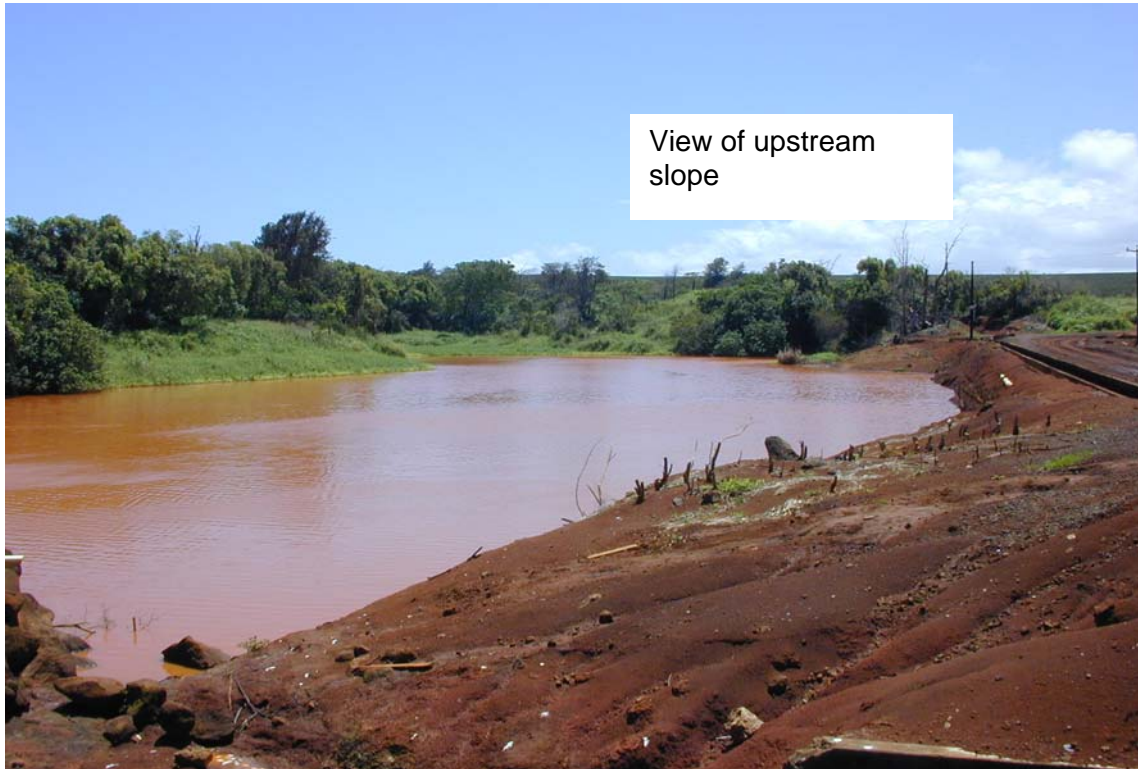
There was no slope protection observed.

Ruts and gullies produced by erosions were observed.

- a. The upstream slope appeared to be in fair to poor condition and requires corrective action.
- b. Slope protection needs maintenance or repair. Description: Slope steeper than 1:1 needs checking.
- c. Rut and/or Gully erosion were observed on the slope, which requires maintenance and/or repair. Description: The gullies are parallel to the slope indicating erosion by runoff, these are likely to get deeper and wider.

View of upstream
slope

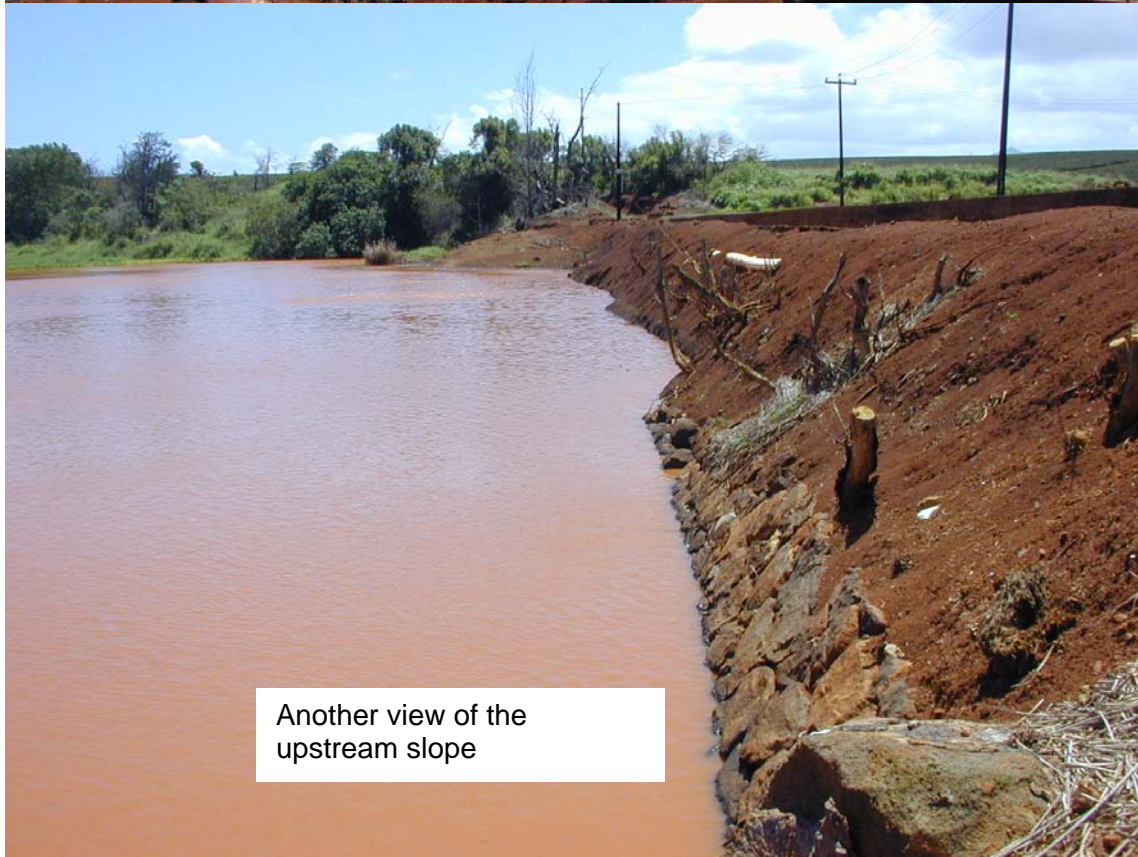
Another view of the
upstream slope

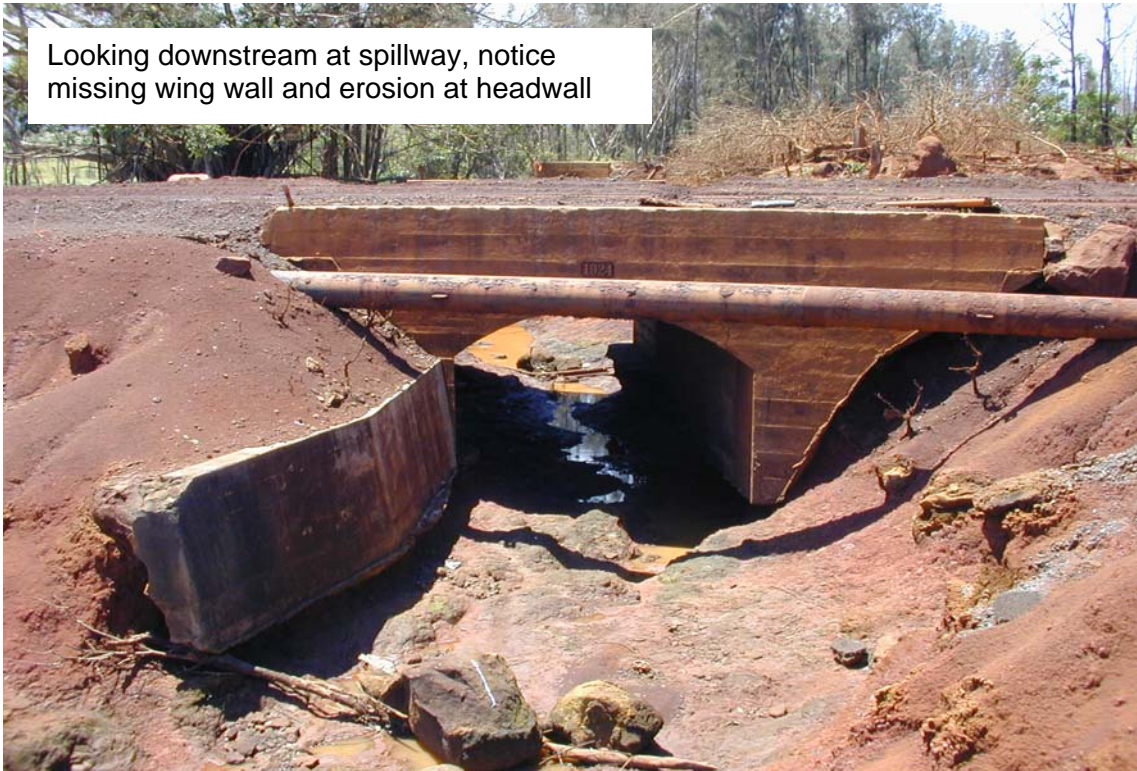
The spillway approach was clear but the right wingwall is missing.

- a. The Spillway appeared to be in fair to poor condition and requires corrective action.
- b. Slope protection needs maintenance or repair. Description: Provide protection against erosion observed.
- c. Severe scour erosion was observed which requires maintenance and/or repair. Description: Deep erosion seen at the approach, headwall, downstream beyond the lined section.
- d. A headcut was observed downstream of the spillway. Corrective / mitigative action is required to prevent this problem from moving upstream.
- e. Unclear if spillway is adequately sized. Spillway should pass the probable maximum flood. Verify spillway capacity and take corrective action as required.
- f. Monitor dry erosion.

Looking downstream at spillway, notice missing wing wall and erosion at headwall

Erosion: ☐ Scour ☒ Gully ☐ Headcut ☐ Not Observed ☐ Other: Erosion on both sides of wing wall and headwall

Description: one wing wall missing

- ☒ d. Slope protection needs maintenance or repair. Description: _____
- ☐ e. The spillway approach was blocked. Clear approach.
- ☒ f. Severe scour erosion was observed which requires maintenance and/or repair.
Description: Down stream
- ☐ g. A headcut (vertical drop in channel due to erosion) was observed downstream of the spillway. Corrective action is required to prevent this problem from moving upstream.
- ☐ h. Trees are unacceptable in the spillway channel and approach. Take corrective action to address the woody vegetation problem and repair the damaged area.
- ☐ i. Unclear if spillway is adequately sized. Spillway should pass the probable maximum flood. Verify spillway capacity and take corrective action as required.
- ☒ j. Monitor deep erosion

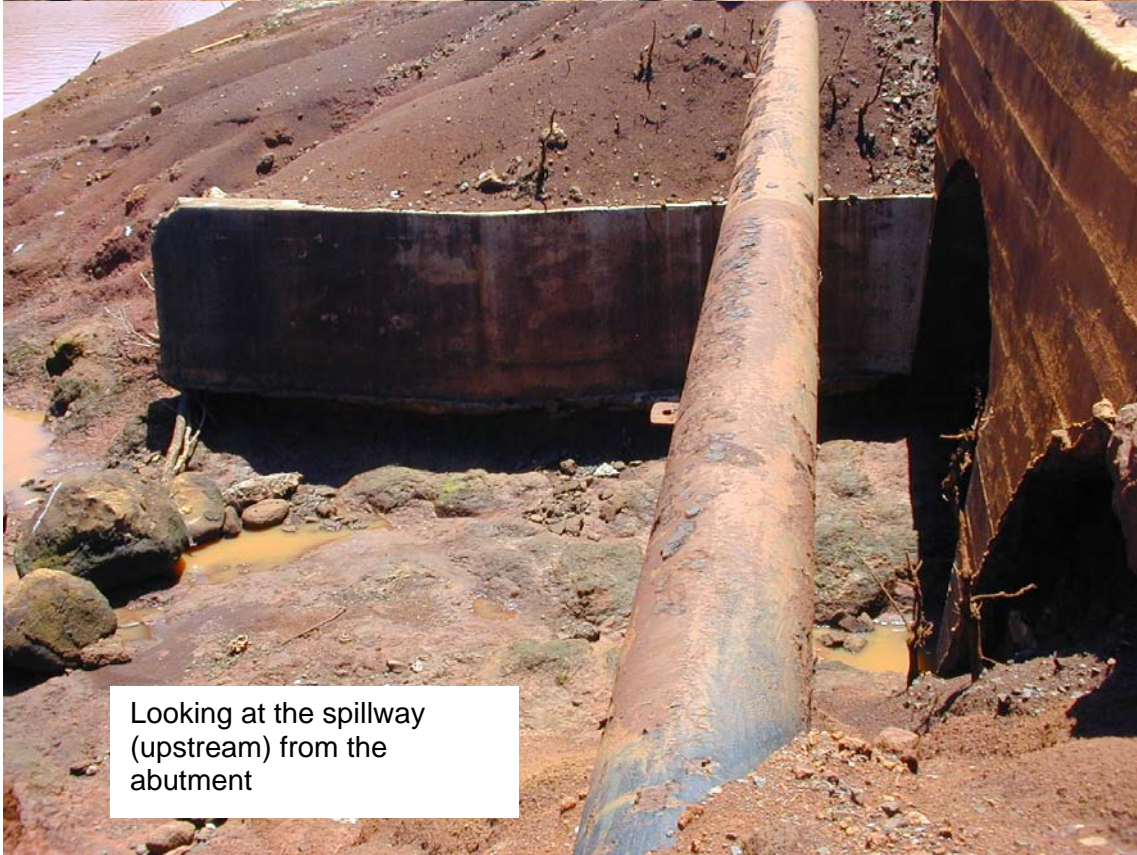
Looking at the spillway
(upstream) from the
abutment

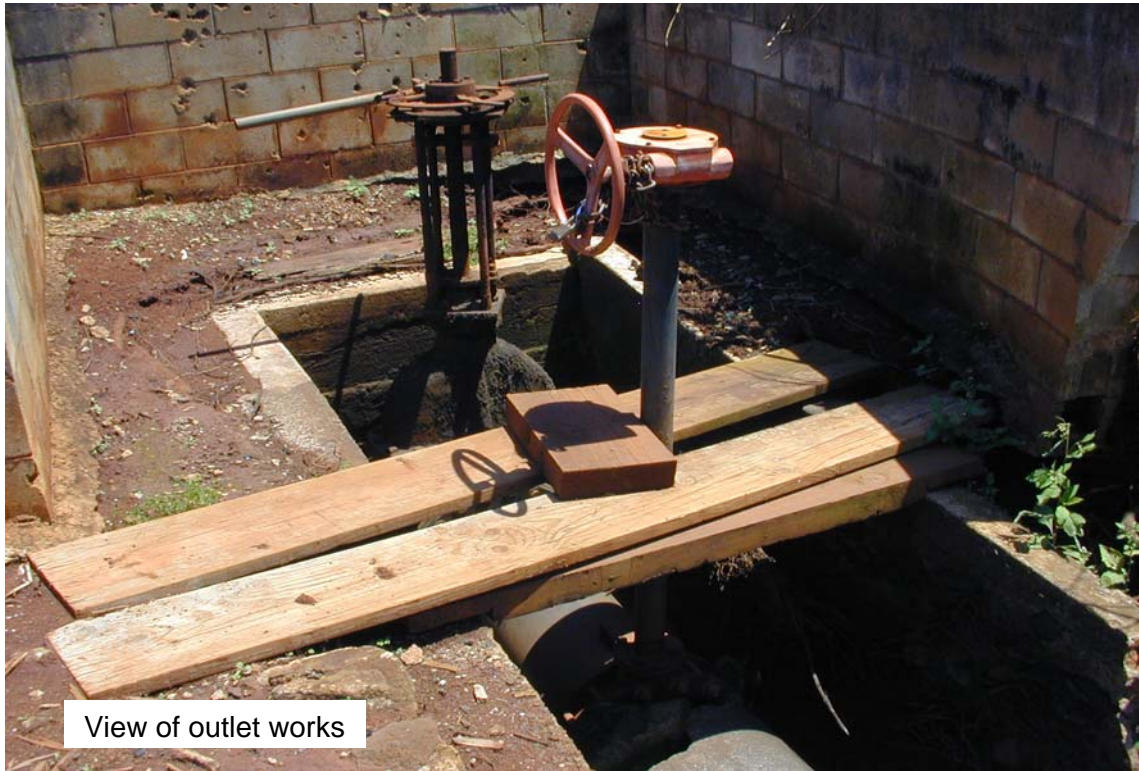
- a. The outlet works were not tested.
- b. The outlet works appeared to be in satisfactory condition, no corrective actions are required at this time.

View of outlet works
